Manhole Inspection Summary

Manhole # S33EE2010MH

Location Address: **5609 PURLINGTON WAY**

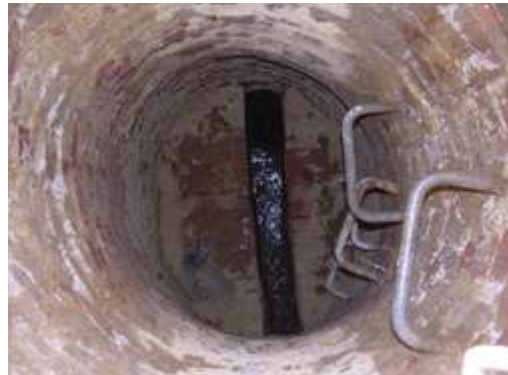
Top View

Bench and Channel debris.

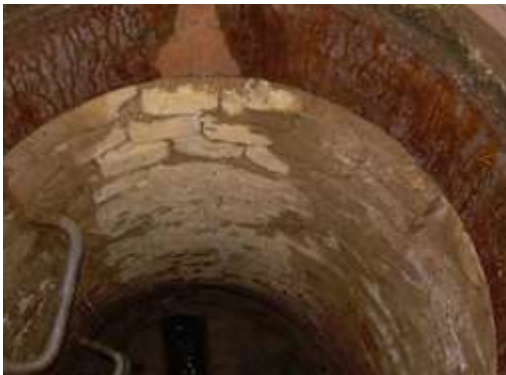
Defect

Adjustment deterioration and infiltration.
Corbel and Barrel infiltration - other side.

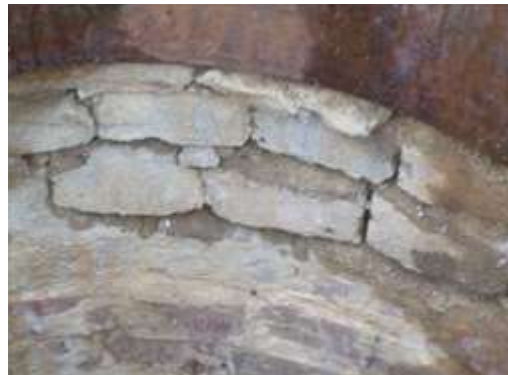
Defect

Adjustment deterioration, loose brick, and
infiltration.

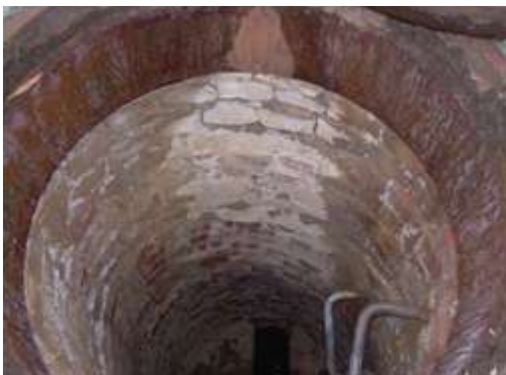
Defect

Adjustment deterioration and infiltration.
Corbel and Barrel infiltration - other side.

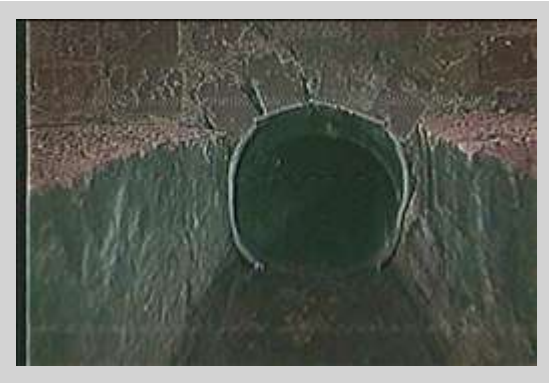
8 in. Circular Gravity Sewer Pipe Out @ 12 O'Clock

Deposits: ☐ None ☒ **Mud** ☐ Sludge ☒ **Debris** ☐ Grease

Silt Depth: **0.5** (in.) Deposits Extent: **Light**

Infiltration: **Evidence** Pipe Seal Cond: **Cracked**

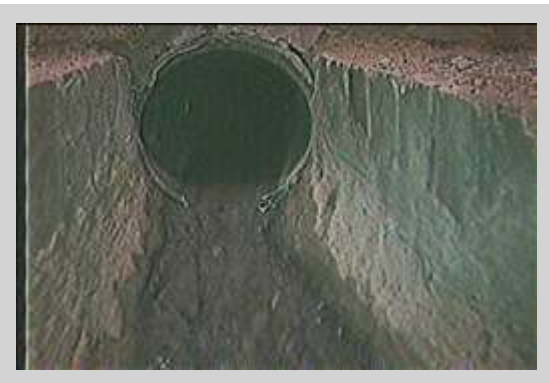
8 in. Circular Gravity Sewer Pipe In @ 6 O'Clock

Infiltration: **Evidence** Pipe Seal Cond: **Cracked**
